GREEN VALLEY INSPECTIONS INC

RESIDENTIAL INSPECTION

17692 Cassia Tree Ln
Irvine, CA 92612

Faryaneh Kashef
09/25/2025

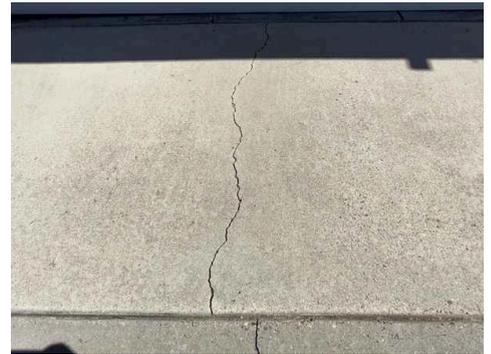
3.1.1 Driveway & Walkways

MINOR DRIVEWAY CRACKING

Minor cracking was observed in the concrete driveway. These small cracks are typical and often result from normal wear, settling, or weather exposure. While they do not appear to pose a significant concern at this time, periodic monitoring is recommended to ensure they do not worsen or develop into larger issues

Contact a qualified concrete contractor.

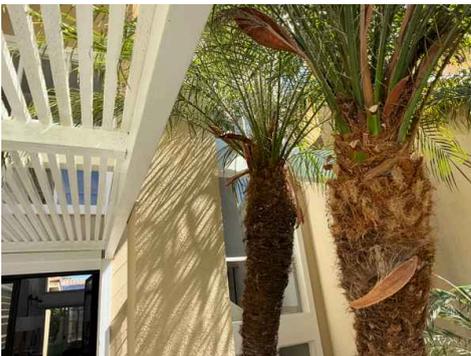
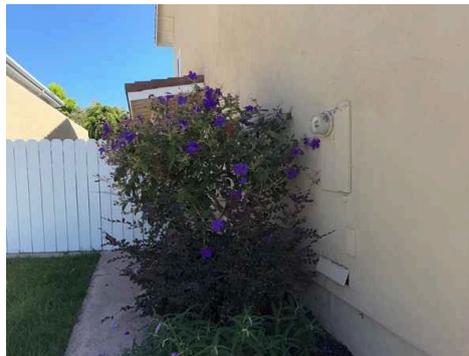
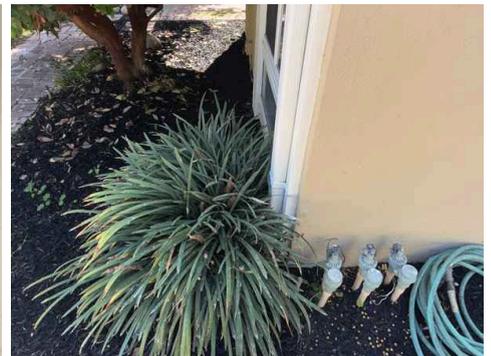
3.6.1 Vegetation

PRUNE

Vegetation was observed in contact with the home. This condition can trap moisture, promote pest intrusion, and potentially cause damage to the siding or structure over time. It is recommended to trim back or remove the vegetation to maintain proper clearance and protect the home.

Contact a qualified landscaping contractor

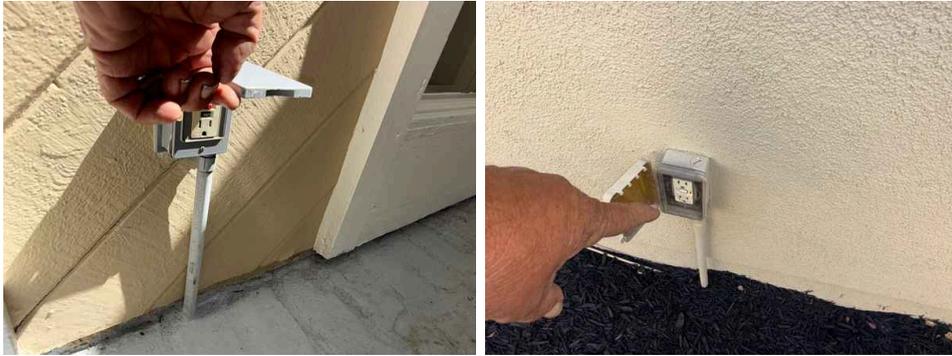
3.7.1 Electrical

GFCI UNRESPONSIVE

The GFCI outlet was found to be unresponsive during testing and did not reset or provide power as intended. This condition may indicate a malfunction or internal damage to the outlet. It is recommended to have the GFCI outlet inspected and replaced by a licensed electrician to restore functionality and ensure safety.

Contact a qualified electrical contractor.

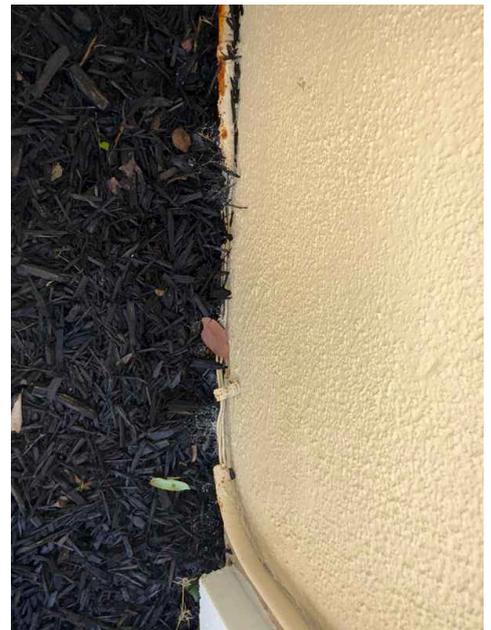
3.7.2 Electrical

DAMAGED CONDUIT

Damaged electrical conduit was observed. This condition can expose wiring to physical damage, moisture, or environmental elements, increasing the risk of electrical failure or safety hazards. It is recommended to have the damaged conduit inspected and repaired or replaced by a licensed electrician to ensure proper protection and compliance with electrical standards.

Contact a qualified professional.

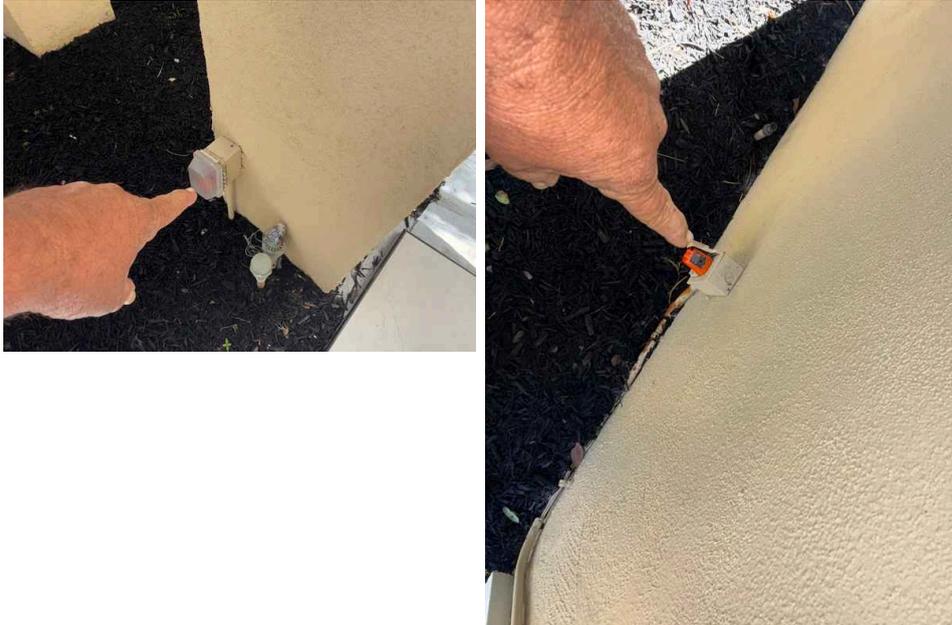
3.7.3 Electrical

An outlet was found to have no power at the time of inspection. This condition may be caused by loose wiring, a disconnected circuit, or a defective outlet.

It is recommended to have the outlet inspected and repaired by a licensed electrician to identify and address the cause of the issue. Ensuring proper function of all outlets is important for safety and usability.

Contact a qualified professional.

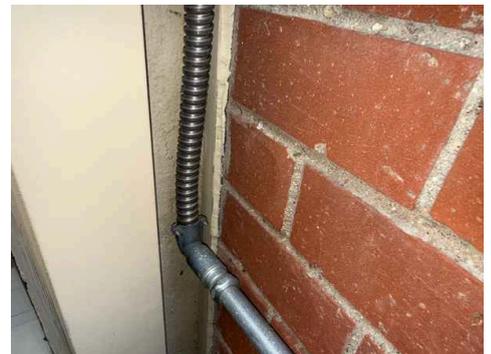
3.7.4 Electrical

**IMPROPER WIRING CONDUIT**

Flexible metal conduit was observed installed on the home's exterior; this type of conduit is not rated for outdoor exposure and is subject to corrosion and damage. Replacement with an exterior-rated conduit by a licensed electrician is recommended.

Contact a qualified professional.

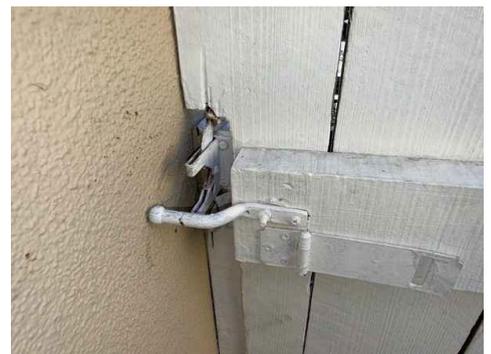
3.8.1 Gates, Fences and Walls

Damaged or missing hardware was observed on the gate. This condition may affect the gate's functionality, security, and ease of operation. It is recommended to have the hardware repaired or replaced by a qualified professional to restore proper functionality and ensure the gate operates as intended.

Contact a qualified professional.

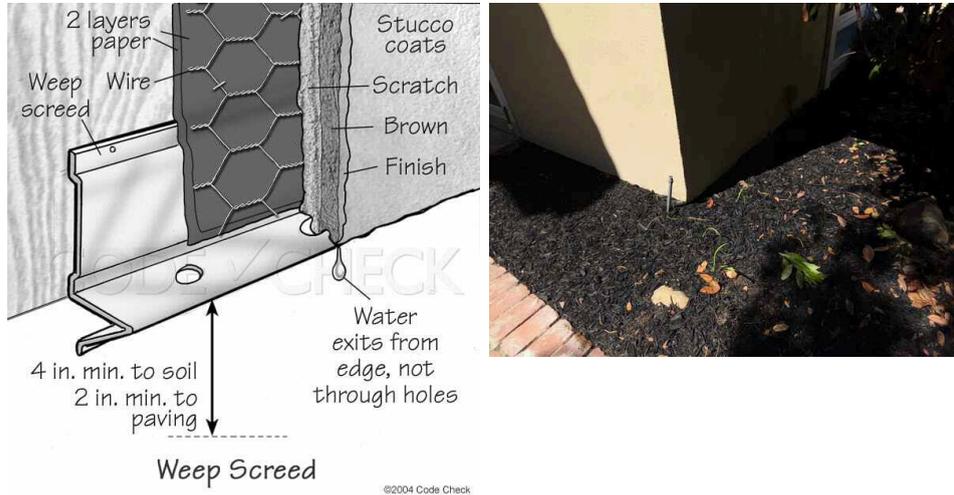
3.9.1 Grading

The soil was observed to be covering the weep screed at the base of the stucco wall. This condition can trap moisture against the wall, potentially leading to stucco damage, wood rot, or pest intrusion. It is recommended to lower the soil level to expose the weep screed and maintain proper clearance to allow for adequate drainage and ventilation.

Contact a qualified landscaping contractor

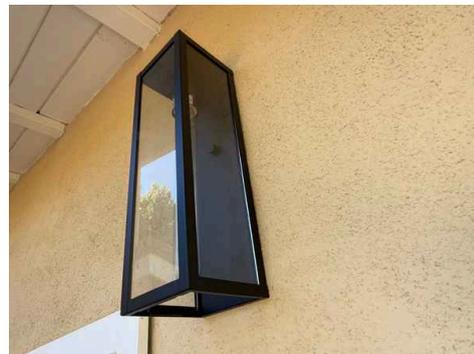
4.4.1 Paint

The exterior of the home has areas where sealing or caulking is missing, deteriorated, or insufficient, which may allow moisture intrusion, air leaks, or pest entry. It is recommended to apply fresh, high-quality exterior-grade caulking to all gaps, joints, and seams to protect the structure and improve energy efficiency. Regular inspections and maintenance of exterior caulking are advised to ensure the home's integrity and longevity.

Contact a handyman or DIY project

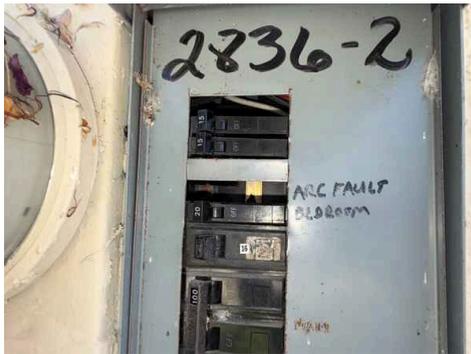
The electrical panel has open cover slots, leaving internal components exposed and increasing the risk of accidental contact, debris entry, or pest intrusion. It is recommended to install appropriate filler plates or covers to seal the open slots and restore the panel's safety and integrity.

Contact a qualified professional.

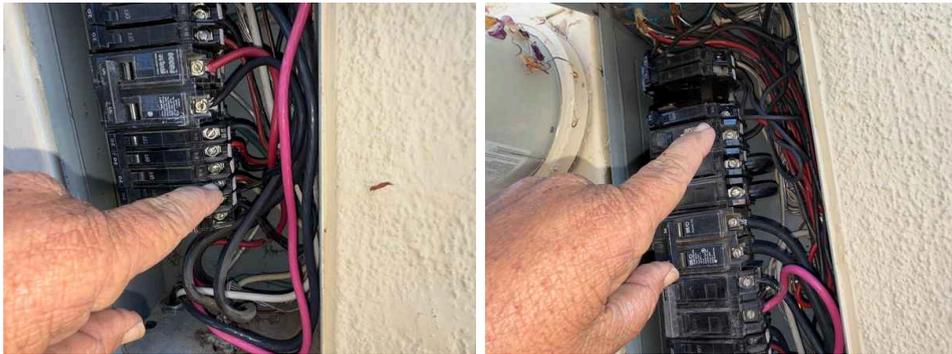
5.2.2 Main Service Panel

The inspector found old technology solid aluminum branch wiring in this house. This wiring, usually installed during the 1960s to mid-1970s can be problematic in both performance and for insurance coverage purposes. Devices connected directly to aluminum wire that are not CO-ALR or CU-AL type may have possible overheating issues. We recommend that the aluminum wired devices be inspected and repaired as necessary by an electrician familiar with aluminum wire repairs. We also recommend that you research with various electricians the cost for this investigation/repair prior to the end of the inspection contingency period.

Contact a qualified professional.

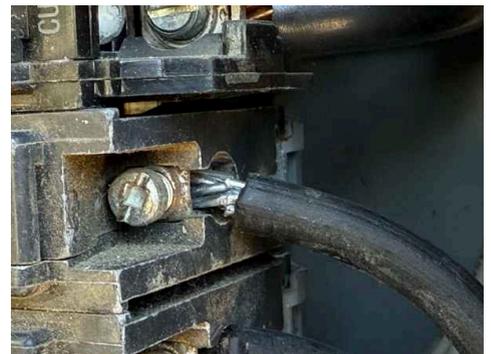
5.2.3 Main Service Panel

The branch circuit conductor has been improperly trimmed to fit the breaker lug, which compromises the conductor and creates a potential safety hazard; evaluation and correction by a licensed electrician is recommended.

Contact a qualified professional.

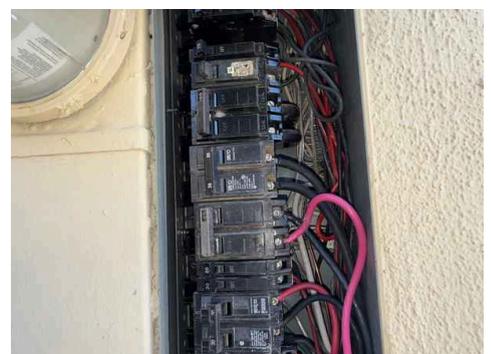
5.3.1 Breakers / Fuses

Observed multiple breakers from different manufacturers installed in the electrical panel. Electrical panels are typically designed for use with specific breaker types and manufacturers, as indicated by the panel's labeling. Using incompatible breakers can lead to poor connections, overheating, or other safety concerns. Recommend evaluation by a licensed electrician to confirm compatibility and replace any breakers as necessary to ensure safe and proper operation.

Contact a qualified electrical contractor.

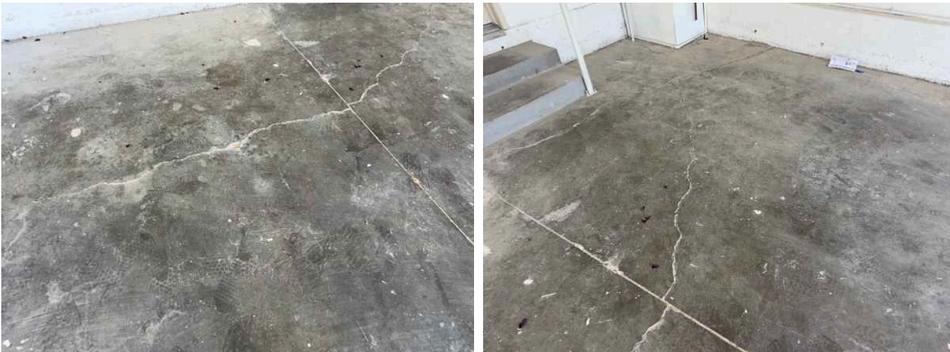
6.3.1 Floor

CRACKING

Cracking visible in the garage floor. Recommend repairs

Contact a qualified structural engineer.

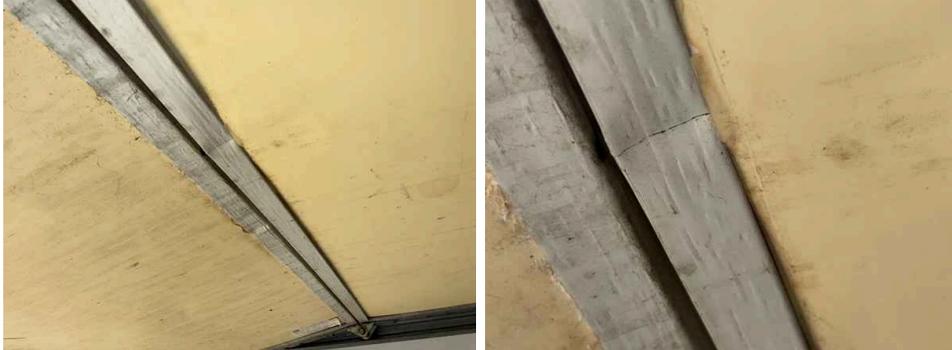
6.4.1 Garage Door

**PANEL DAMAGE**

Garage door panel is damaged and may need repair/replacement. Recommend a qualified garage door contractor evaluate.

Contact a qualified garage door contractor.

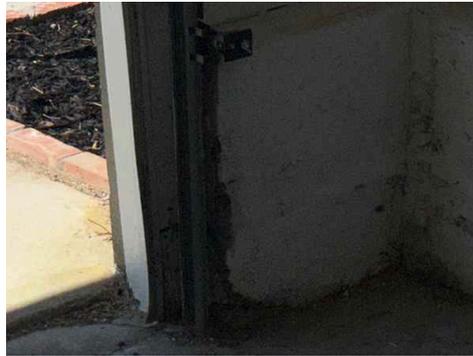
6.6.1 Garage Door Opener

AUTO REVERSE SENSORS MOUNTED TOO HIGH

Contact a qualified professional.

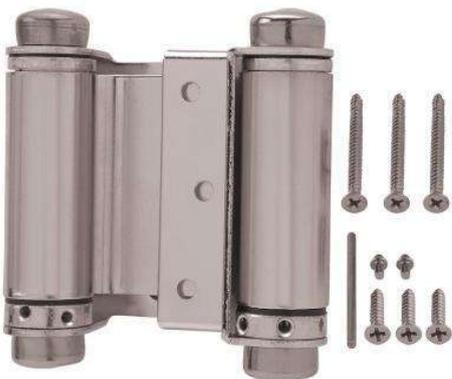
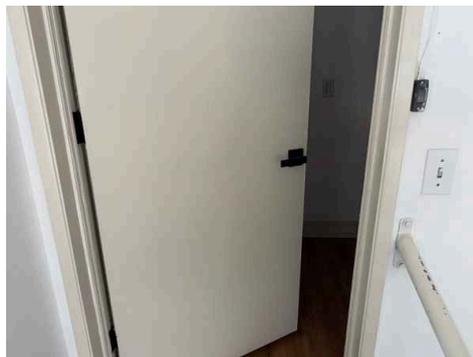
6.8.1 Occupant Door (From garage to inside of home)

NOT SELF-CLOSING

Contact a qualified door repair/installation contractor.

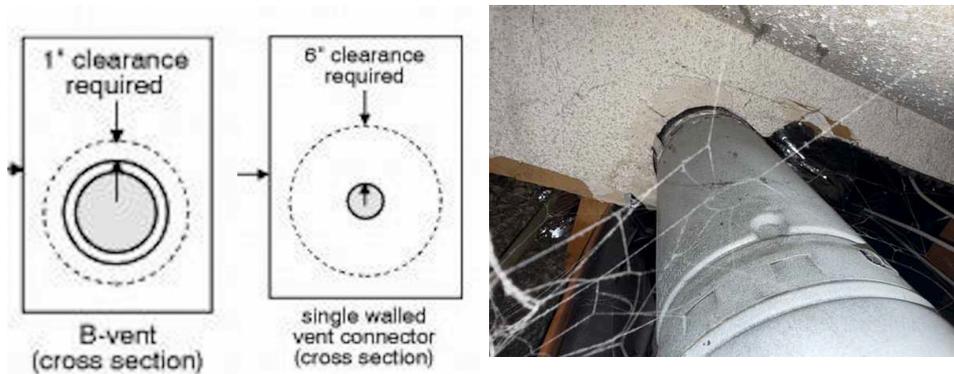
8.3.1 Heater(s)

FUEL SERVICE

Contact a qualified professional.

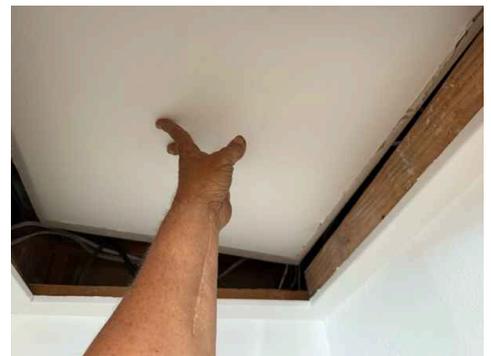
8.10.1 Registers

IMPROPER USE OF WALL AND CEILING CAVITIES AS DUCT CHASES

Contact a qualified professional.

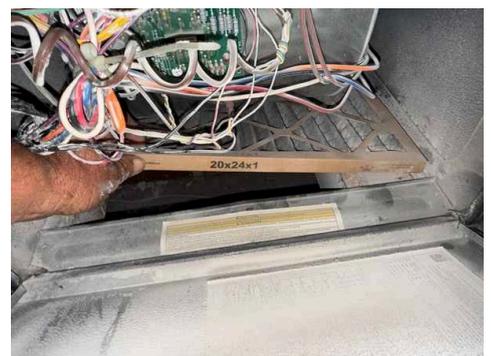
8.11.1 Filters

MISSING HOLD DOWN BAR

Contact a qualified professional.

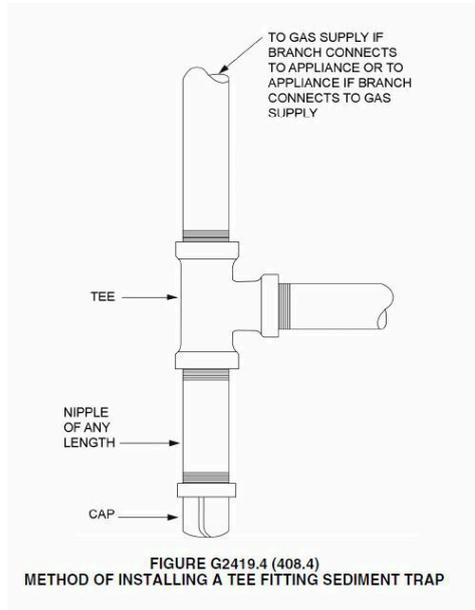
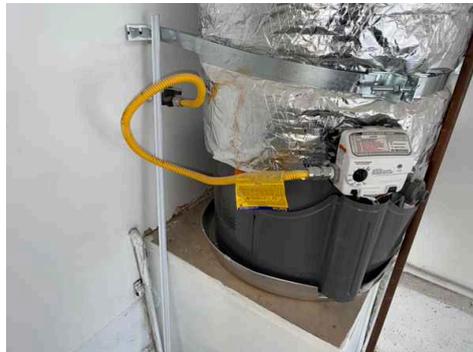
9.6.1 Gas Valves

sediment trap example

Contact a qualified professional.
