GREEN VALLEY INSPECTIONS INC

RESIDENTIAL INSPECTION

17692 Cassia Tree Ln
Irvine, CA 92612

Faryaneh Kashef
09/25/2025

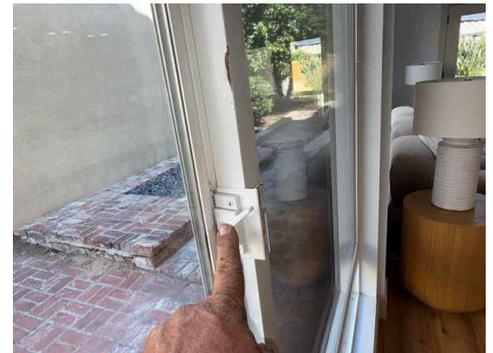
One or more windows did not lock/latch properly, recommend repairs for enhanced security/safety to occupants.

Contact a qualified professional.

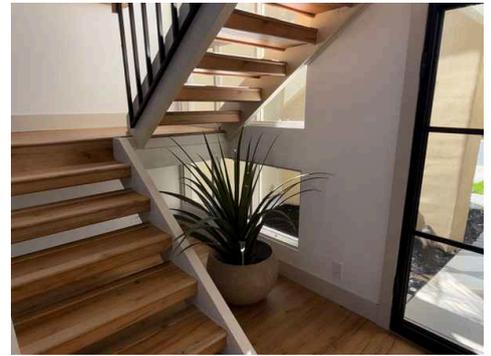
MISSING HANDRAILS

Missing handrails Recommend installing

Immediate Action Needed
